CONNECTICUT RIVER BASIN
LEBANON, NEW HAMPSHIRE

CUMMINGS DAM
NH 00154

PHASE I INSPECTION REPORT
NATIONAL DAM INSPECTION PROGRAM

FEBRUARY 1979

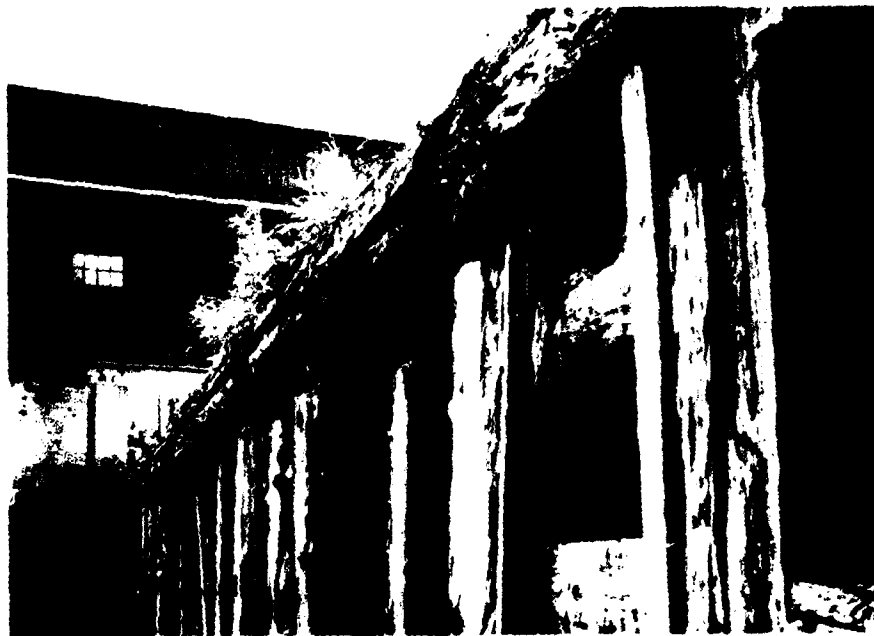
Much of the timber (approximately 12" x 12") that comprise the principal structural elements of the dam are very badly deteriorated, some have fallen, and some are missing. (See Appendix C - Figures 7, 8, 9 and 10.) Many of the large bolts and metal dogs that fasten the timbers together are badly rusted, loose, or missing. (See Appendix C - Figure 11.) The plank facing on the upstream side of the dam is badly deteriorated. Leakage through the plank facing is occurring over the entire length of the dam; at the east end of the dam there is a slowly moving whirlpool above one of the areas of greatest leakage. (See Appendix C - Figure 4.) The dam rests on a bedrock foundation. Several of the timbers at the base of the dam are resting on large boulders which in turn rest on the rounded, downstream-sloping bedrock surface. Although these boulders were apparently placed deliberately to provide a horizontal base for the dam, and have presumably been in place for many years, they appear to be only marginally stable. (See Appendix C - Figure 2.) In the limited areas that could be safely inspected, there was no mechanical anchorage of the timber dam to the rock foundation. Numerous steel pins were observed embedded in the rock under the dam; however, none appeared to be connected to the support timbers for anchorage. It appears the friction between the timbers and rock provides the only resistance against sliding of the dam. The crest of the dam bulges downstream approximately one foot near the center of the dam, as estimated visually from a point on the east abutment. (See Appendix C - Figure 3.)

Figure 9 - Looking across the downstream face of the dam from the east toe.

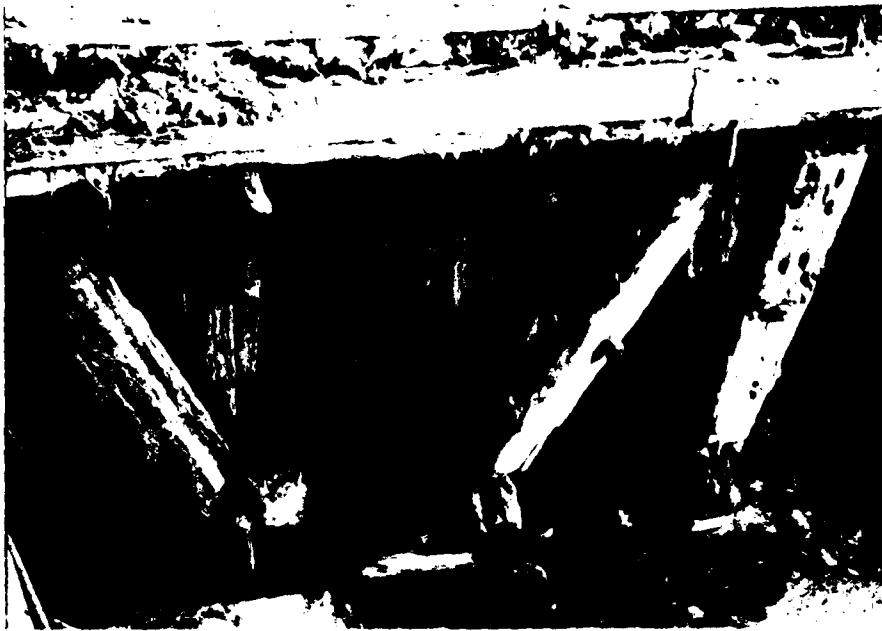
Figure 10 - Looking at fallen support columns.

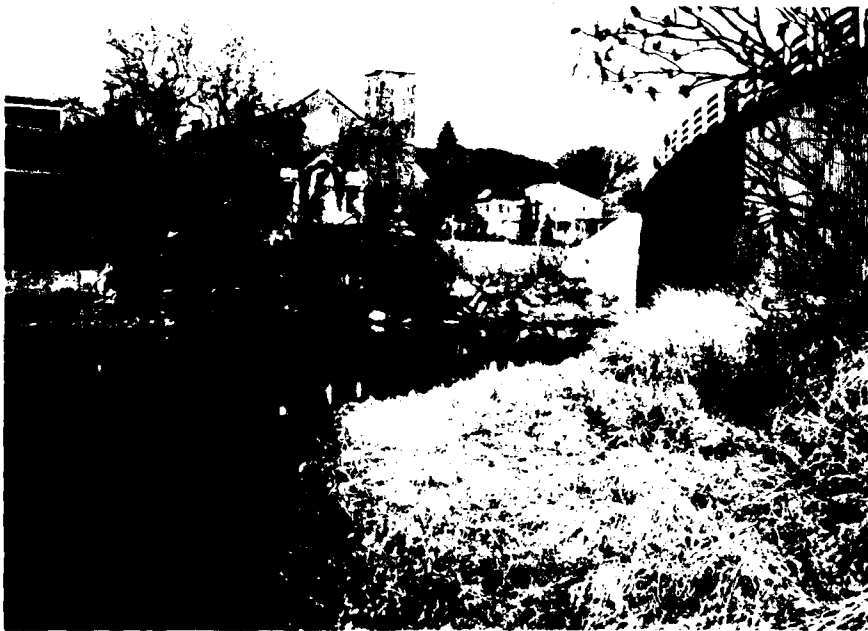
Figure 13 - Looking upstream from the east abutment.
